**Re: NESHAP Asbestos-Containing Materials Survey
Jefferson Elementary, 515 Bryant Ave.
Villa Environmental Consultants, Inc. Project No. 22-244**

Jefferson Elementary School ACM Sampling

Figure 1
Functional Space Diagram

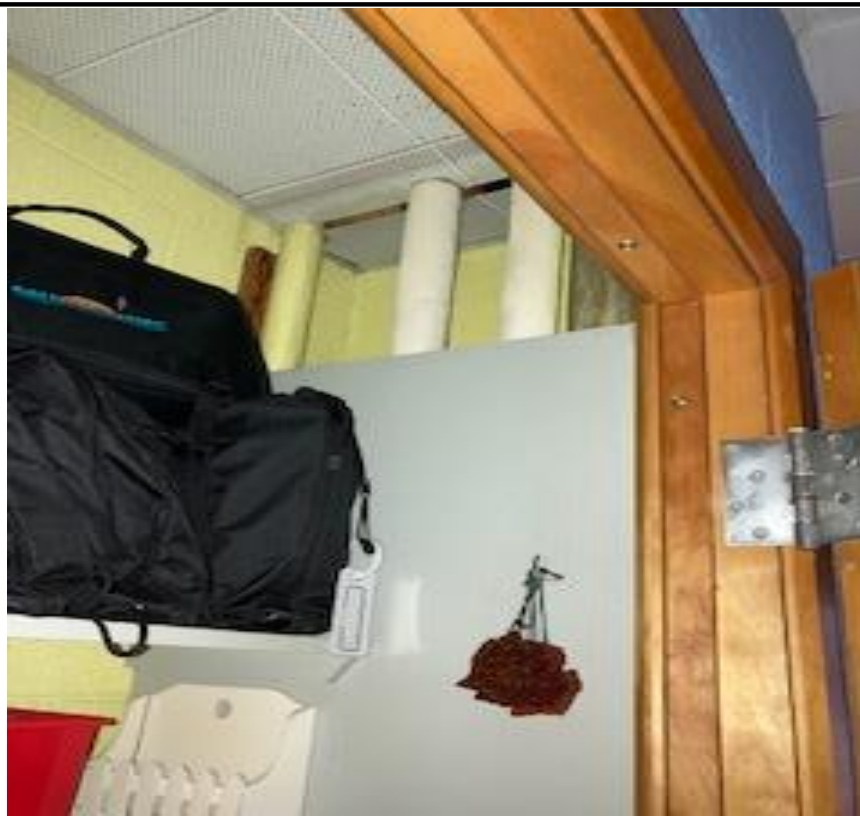
HA No.	Homogenous Area Description	Condition	Friable (Yes/No)	EPA Category	Estimated Quantity
3	Mag-Insulation	G	Y	II	20 LF
12	9"x9" Floor Tile	G	N	I	16,840 SF
13	Exterior Transite Soffit-1963 section	G	N	II	550 SF
23	Boiler Flue Liner in Chimney-Assumed ACM	G	N	II	250 SF
29	Exterior Door Caulk-1953 Section	G	N	I	8 SF
37	Removable Wall-Assumed ACM	G	N	II	240 SF
39	Vermiculite in the exterior walls- Assumed	G	N	II	8500 SF

HA#3 Mag insulation riser in office closet

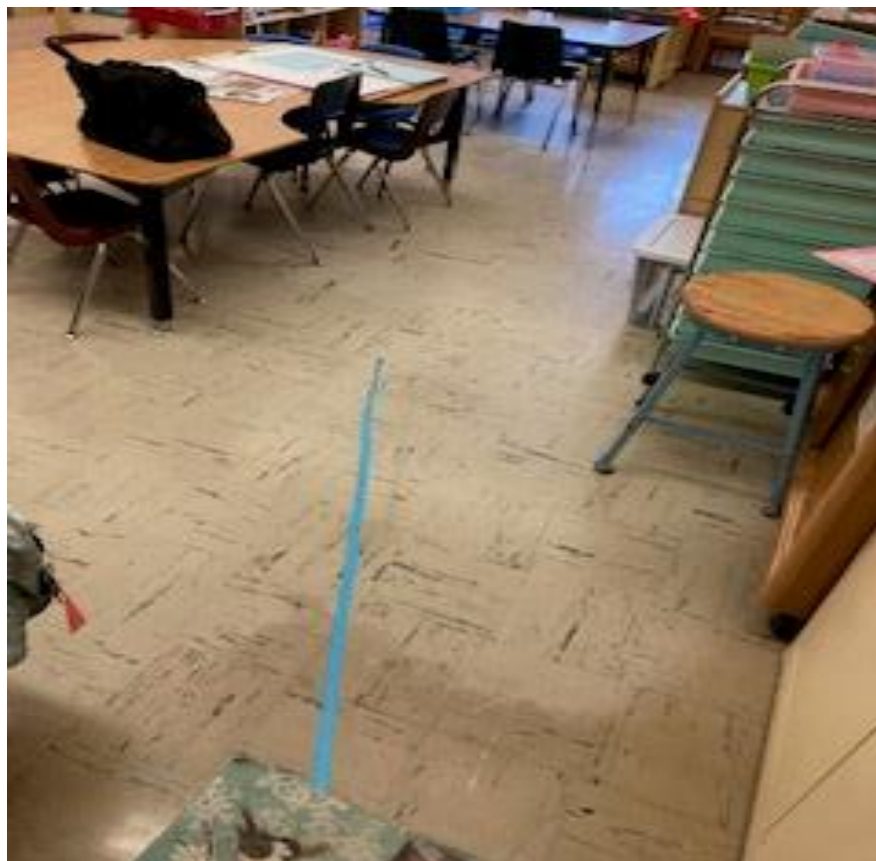
HA#12- Typical 9"x9" floor tile

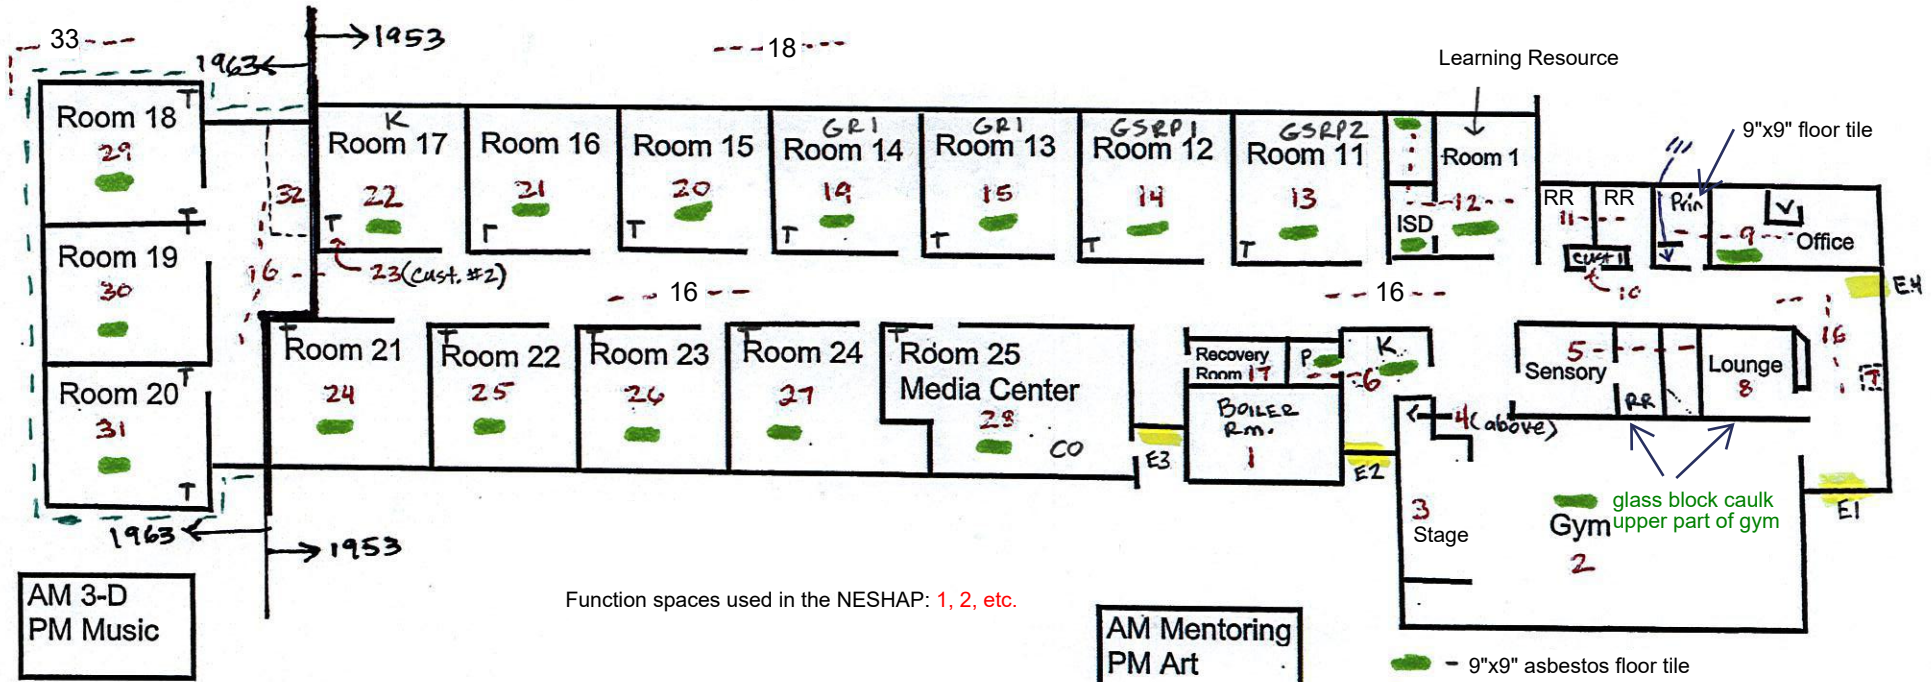
- 9"x9" asbestos floor tile
-

- asbestos door caulk
-

- Mag (asbestos) pipe insulation riser that may also be in wall cavities and in isolated areas
-

- Transite soffit

Assumed asbestos vermiculite insulation in exterior wall cavities.

- There could be isolated areas that have asbestos floor tile under carpet and casework.
- Prior to demolition we recommend breaking into exterior walls to look for possible vermiculite, break into walls associated with plumbing to look for asbestos pipe insulation, look under exterior metal fascia in 1963 section to verify transite, demolish the roof skylights to look for possible transite, assure there is no insulation on pipes in the concrete floors (almost all) that have radiant heat in 1953 section, demolish the exterior upper renovated areas that are covering glass block and maybe transite, and look under the hallway ceramic floor tile.
